U.S. DEPARTMENT OF TRANSPORTATION FEDERAL AVIATION ADMINISTRATION		STATEMENT OF COMPLIANCE WITH AIRWORTHINESS STANDARDS	
FAA Project No. NA		Piper Project No. Y12500	
AIRCRAFT OR AIRCRAFT COMPONENT IDENTIFICATION			
MAKE Piper Aircraft, Inc.	MODEL NO. PA-31-350	TYPE (Aircraft, Engine, Propeller, etc.) Aircraft	NAME OF APPLICANT/AUTHORIZATION NO. Piper Aircraft, Inc. ODA-510620-CE
LIST OF DATA			
IDENTIFICATION	TITLE		
REPAIR EO: PA-31-350(7405205)/01 Rev. -	<p>NOTE: This Data approval is in support of Organizational Designation Project No. <u>Y12500</u> and is not valid for any other purpose or application.</p> <p>REPAIR OF CORROSION DETECTED COMMON TO RH MAIN LOWER SPAR CAP AT APPROXIMATELY WS 58.50 TO WS 72.50</p> <p>NOTE:</p> <ol style="list-style-type: none"> 1) Only the structural engineering aspects of the above listed data are approved herein. This approval is only for the engineering data. It indicates the data listed above demonstrates compliance only with the regulations specified by paragraph and/or subparagraph listed below as "APPLICABLE REQUIREMENTS". 2) All aspects required for the repair are addressed. 3) Compatibility of this data with the aircraft configuration mu

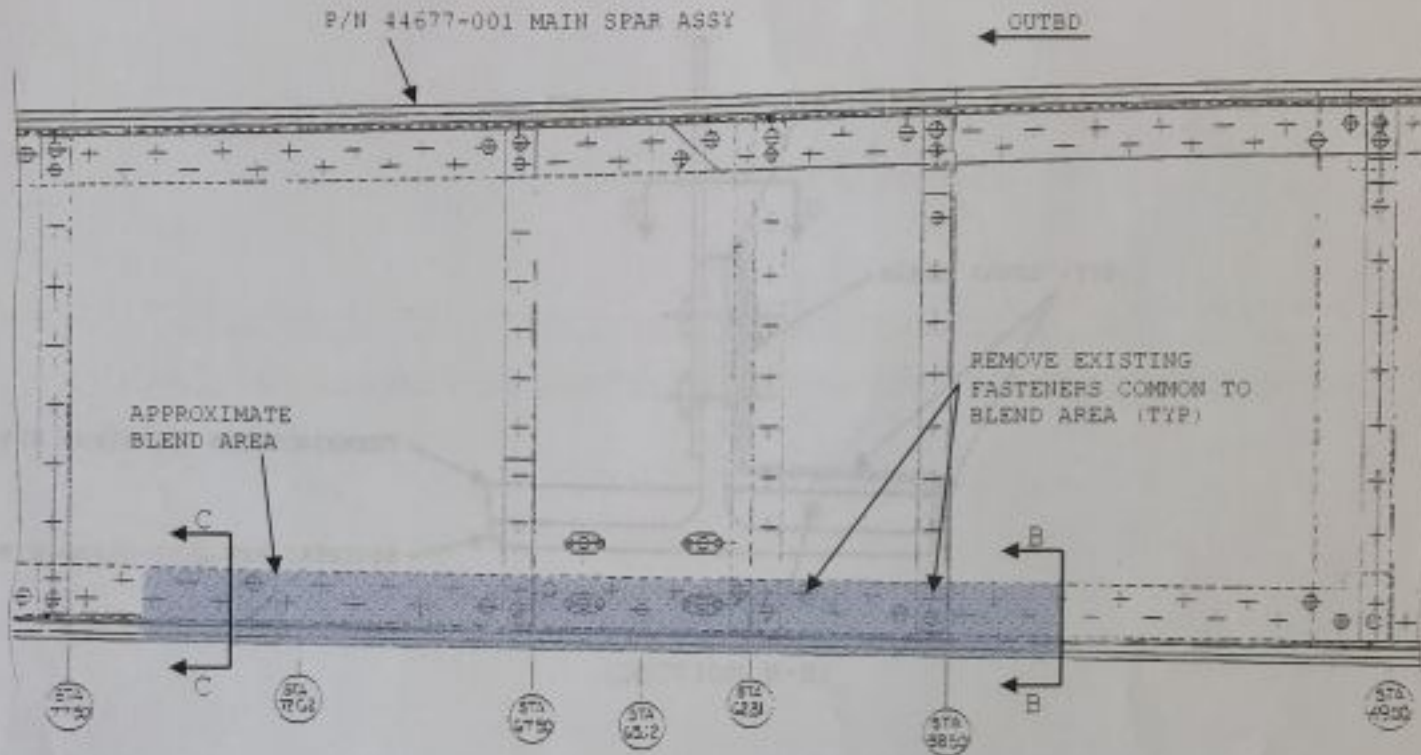
FIGURE 2: DAMAGE LOCATION

(SECTION A-A)
(VIEW LOOKING AFT)

2. For corrosion damage common to the RH Main Wing Spar Assembly (P/N 44677-001), remove damage as shown in Figures 1 thru 5.
 - a. Remove existing fasteners common to the area being reworked.
